**2010 Flood Disaster in Kosofo – Lagos State, Nigeria.
A Summarized Report on Causes and Mitigating Measures.**

NEMA GIS UNIT

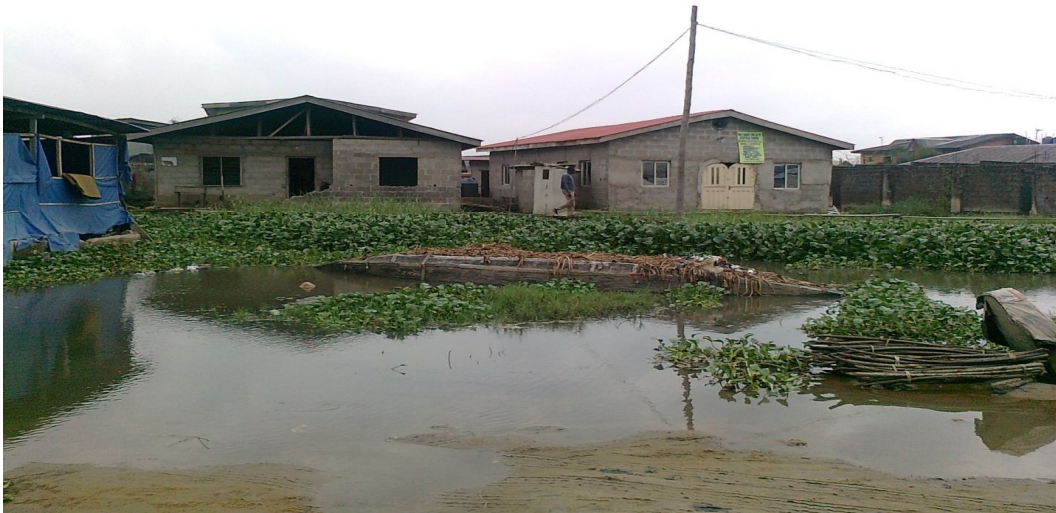
- The area is completely a wetland. **See figure 2.**
- Annually, more wetlands are lost due to rapid urbanization being experienced in Ikorodu and its environs through sand filling.
- Most structures are raised indiscriminately.
- Wastes are disposed into the canals causing blockages. **See figure 3**
- The river/canal is heavily covered by water hyacinth/sea weeds. **See figure 4**

Figure 2. *Houses built on sand filled wetlands*

- Structural development within the wetlands should be prohibited and the natural habitat preserved.
- The water hyacinth on top of the river should be cleared by the relevant Authorities; this will allow free flow of water.
- The residents of the area should be relocated accordingly.
- Proper waste disposal mechanism should be put in place throughout the area.
- Erection of new buildings should be discouraged within the entire wetlands.
- The bridges along the roads should be reinforced to avoid sudden collapse.
- Early warning campaign and sensitization should be intensified through the media for the people to understand the dangerous situation.

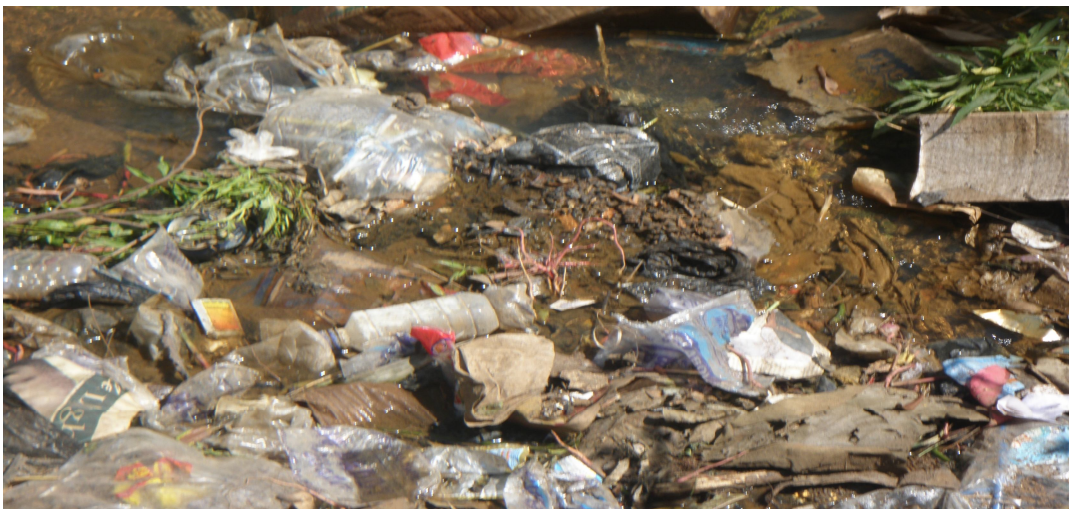
Figure 3. *Refuse in Canals & Water Channels.*

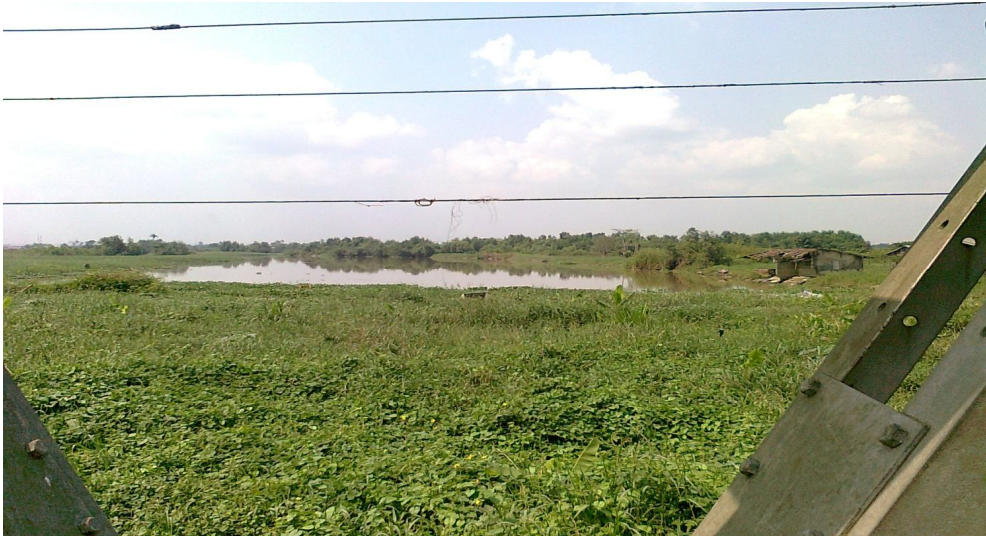
Figure 4. *Water hyacinth/ other Sea Weeds Covering the Canals. All Pictures were Taken December 6, 2010 by (NEMA GIS Unit)*
